The December 26th 2004 Indian Ocean tsunami in Northwest Sumatra and Offshore Islands

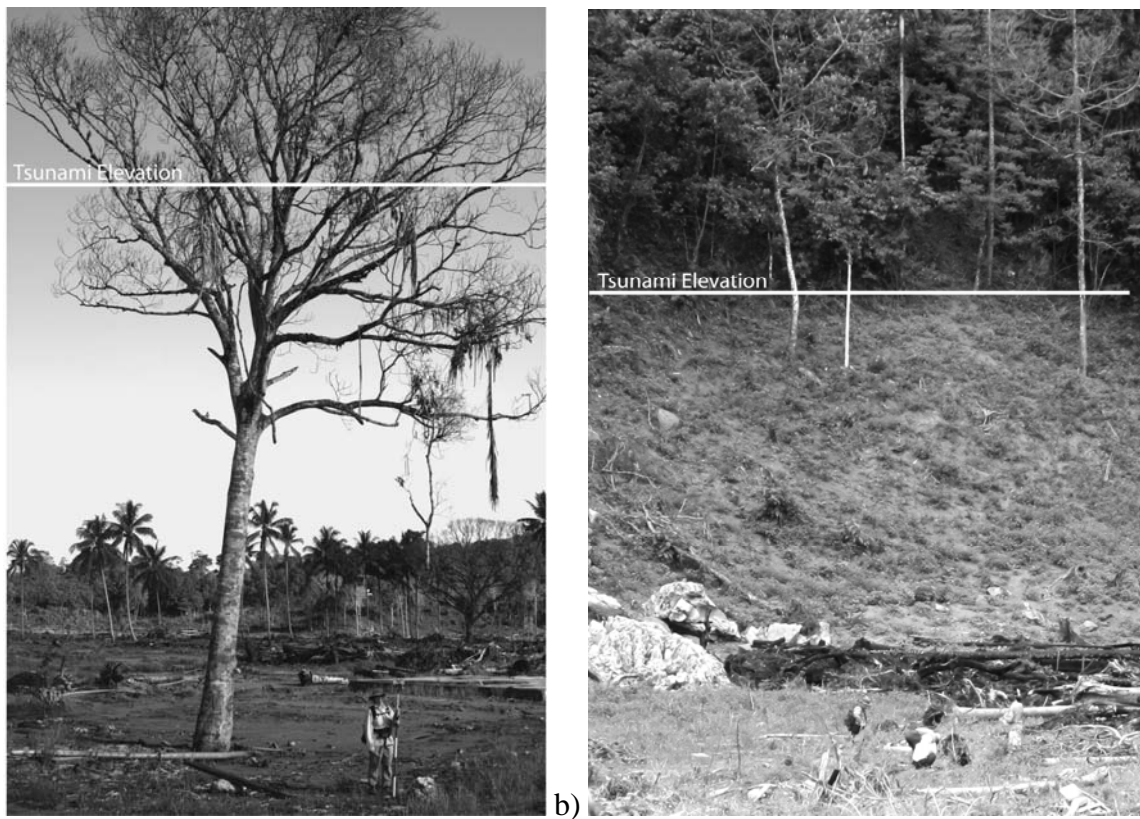
Figure 2. a) Surveying topographic profile in front of a large tree that survived the December 26, 2004 tsunami at Lhok Kruet, Sumatra. Note the branches high in the tree that were broken by the 26 December tsunami. The combination of broken branches and debris high in the tree, primarily palm fronds, indicate that the tsunami flow depth was 9.9 m at this location, which is approximately 275 m inland, b) Trimline at Jantang at 19.7 m above the sea level when the December 26, 2004 hit. Vegetation below the line was stripped by the tsunami and had begun to grow back. Note the team members examining a tsunami deposit in the foreground. Photographs taken by Bruce Jaffe.

Tsunami water levels and topography were measured relative to sea level at the shore using a laser range finder shooting to either a prism on top of a rod or a water level indicator (e.g.; debris in a tree). Water levels measured (Figure 1) included; (1) runup, the elevation at maximum inundation, (2) tsunami elevation, the sum of water depth during the tsunami and elevation relative to the shoreline, and (3) flow depth during the tsunami. Minimum flow depth during the tsunami was indicated by broken branches (Figure 2a) or stripped bark in trees, debris in trees, snapped trees, gouge marks in trees, impact marks on rock outcrops, and water marks on buildings (rare along the sites on the west coast of Sumatra visited by this ITST because nearly all the buildings were destroyed). Runup was indicated either by a wrack line of debris or a trimline, which is the elevation on a hill or cliff below which all vegetation was stripped by the tsunami (Figure 2b).

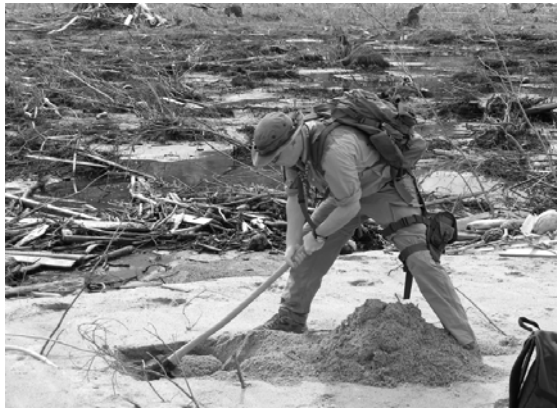
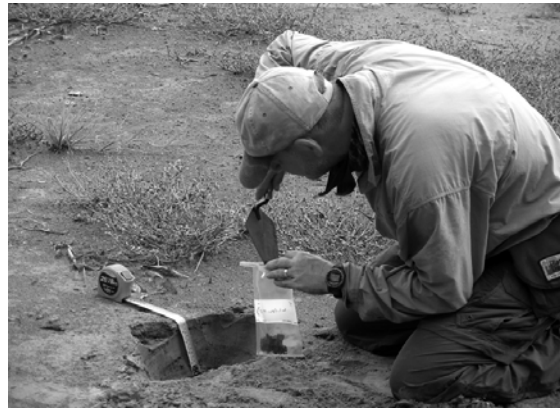
Figure 3. a) Trenching at Jantang, Sumatra. This trench is in a berm that formed several months after the tsunami as the shoreline and nearshore adjusted to coseismic subsidence and erosion from the tsunami. The area landward of the trench was flooded because it subsided during the December 26, 2004 earthquake. Photograph taken by Andy Moore b) Collection of tsunami deposit samples. Samples were transported to the United State for laboratory analyses of grain size. Samples were collected at multiple levels in the deposit to document changes in grain size above the base of the deposit. The goal of collecting these samples is to use them, in conjunction with field observations, photographs, and peels, to develop relations between the tsunami flow and the deposit it leaves (e.g.; flow speed deposit relations). Photograph taken by Bretwood Higman.

Tsunami deposits were examined in pits and trenches dug at intervals along a shore-normal transect and at selected locations off transect (Figure 3a). The deposits were measured, photographed, and described in the field and samples were taken for laboratory analyses. In the field, bulk samples of layers within the deposits were taken, and, at about a

dozen locations, samples were taken at ½ cm or 1 cm intervals to document the fine-scale vertical variation of grain size in the deposit (Figure 3b).

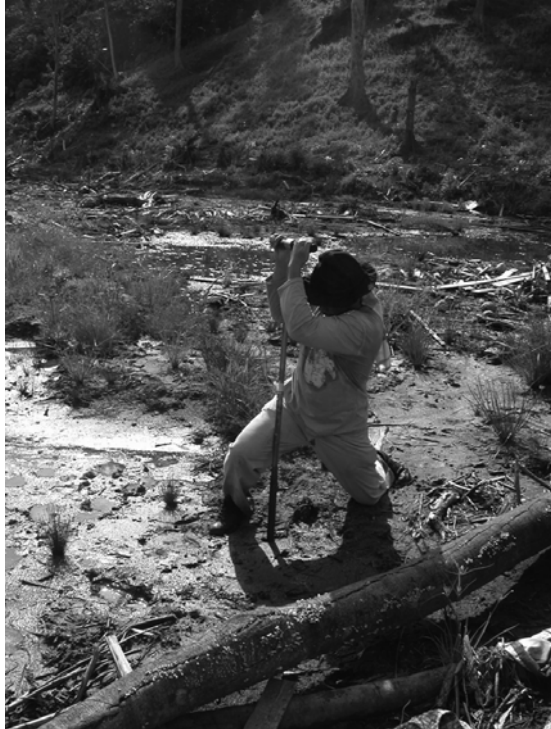
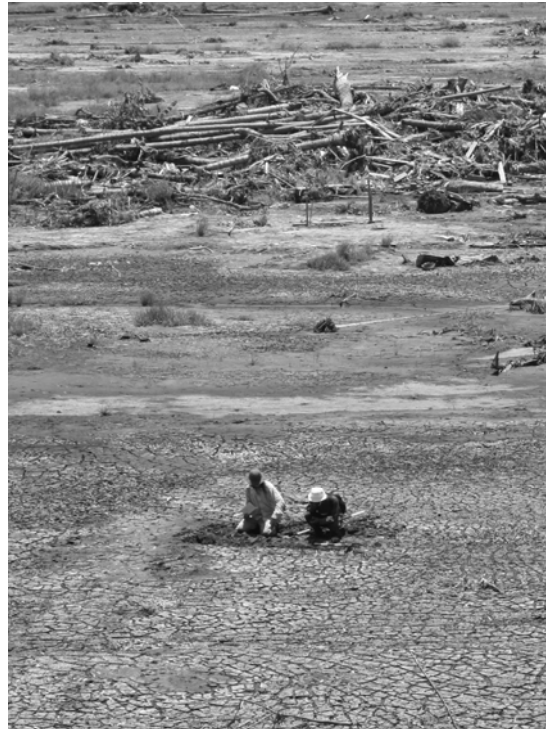
Figure 4. a) Push coring in search of paleotsunami deposits at Jantang. Photograph taken by Lori Dengler. b) ITST members examining trench in tsunami deposit approximately 1 km inland at Kuala Meurisi, Sumatra. Note the laterally continuous nature of the deposit, water ponded in local topographic lows, and mudcracks at the surface of the deposit. The trees in the photograph were ripped up from seaward and transported to this location by the December 26, 2004 tsunami. The trunks are oriented parallel to the tsunami flow direction. Photograph taken by Bruce Jaffe.

At several sites, the ITST searched for paleotsunami deposits by taking push cores in environments with good preservation potential and by examining eroded channel banks and scarps near the shoreline (Figure 4a). Potential paleotsunami deposits were measured, photographed, and described in the field and samples were taken for laboratory analyses.

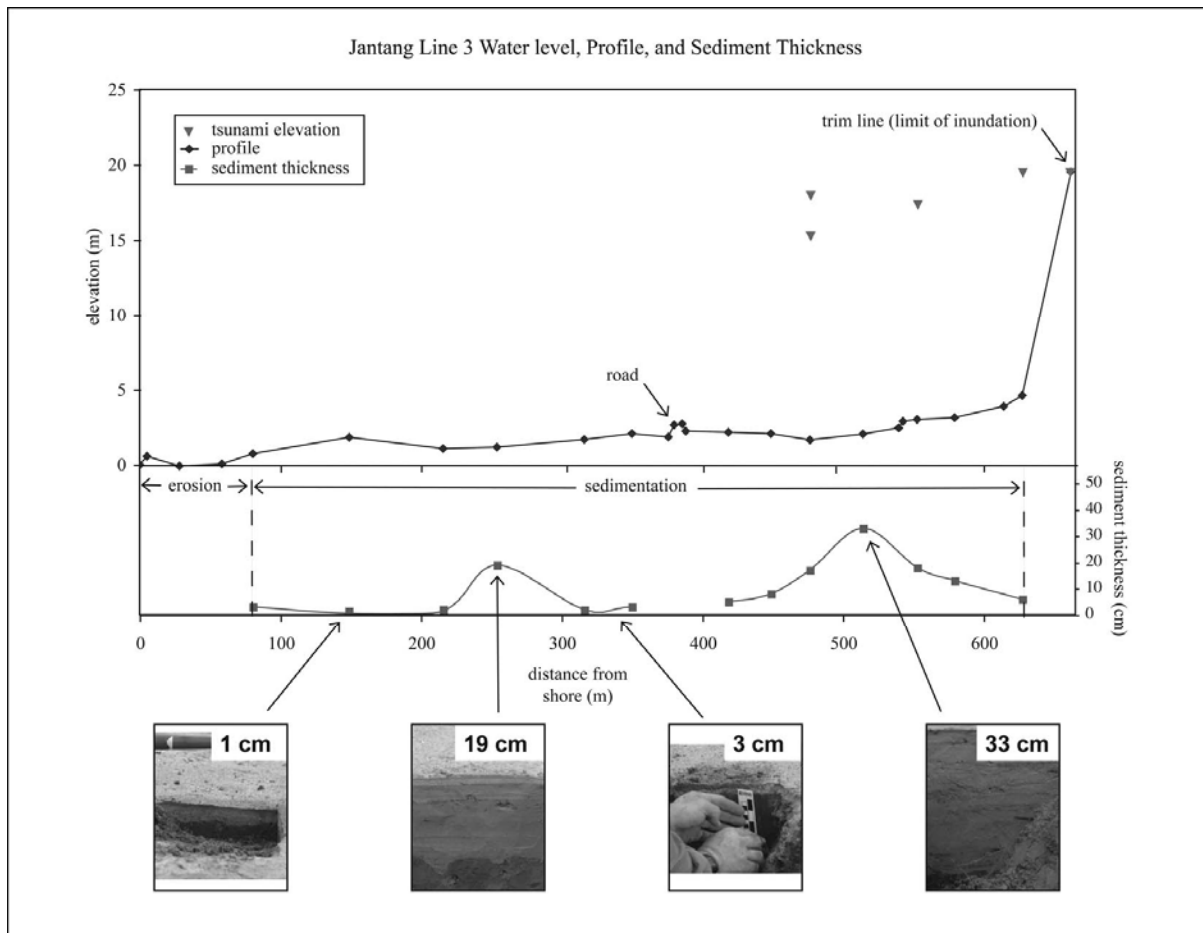
Figure 7. Topographic profile, tsunami deposit thickness, and tsunami flow depths and elevations at Jantang, Sumatra, on transect 3 (center transect in Figure 6). Maximum tsunami flow depth was 16.4 m at 476 m inland and decreased to 15.0 m at 628 m inland, which is 37 m seaward of the trimline. Tsunami elevations increased from 18.1 m to 19.7 m over this section of the transect. Note that there was an erosion zone seaward of the tsunami deposit and that deposit thickness varied along transect, appearing to respond to subtle changes in topographic slope.

Thicknesses of tsunami deposits were variable along transects (Figure 7) and from site to site (Appendix I). At Kuala Meurisi, deposit thickness variation was large in a ridge-swale system with greater thickness in the swales. The maximum deposit thickness observed at any site was 70 cm at , although typical thicknesses were 5 to 20 cm. The thickest deposits did not correlate with the deepest tsunami flow depths (e.g.; Jantang, Figure 7). Deposits were usually composed of multiple layers; thickness may reflect deposition during multiple waves and/or during uprush and return flow.
